# PACSystems™ RX3i

## IC695CPU310-ER

### Central Processing Unit

GFK-2329T  
December 18, 2007

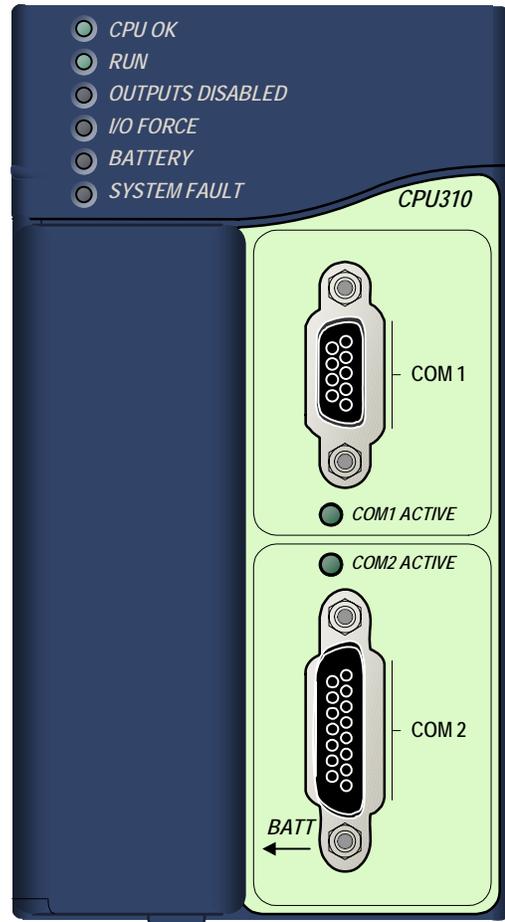
The RX3i CPU can be used to perform real time control of machines, processes, and material handling systems. The CPU communicates with the programmer and HMI devices via a serial port using SNP Slave protocol. It communicates with I/O and Intelligent Option modules over a dual backplane bus that provides:

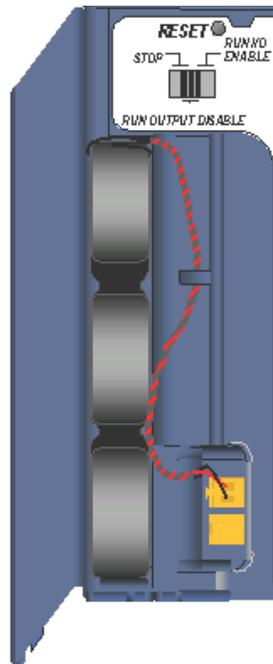
A three-cell lithium battery pack (IC698ACC701) is installed as shown in the figure below. The battery maintains program and data memory when power is removed and operates the calendar clock. When replacing the battery, be sure to install a new battery before disconnecting the old one.

Mode Switch and Battery Compartment
